M/V Hanjin Pennsylvania: Explosions at Sea

This report was prepared on behalf of the National Fireworks Association (NFA).

Final Report - Pictures

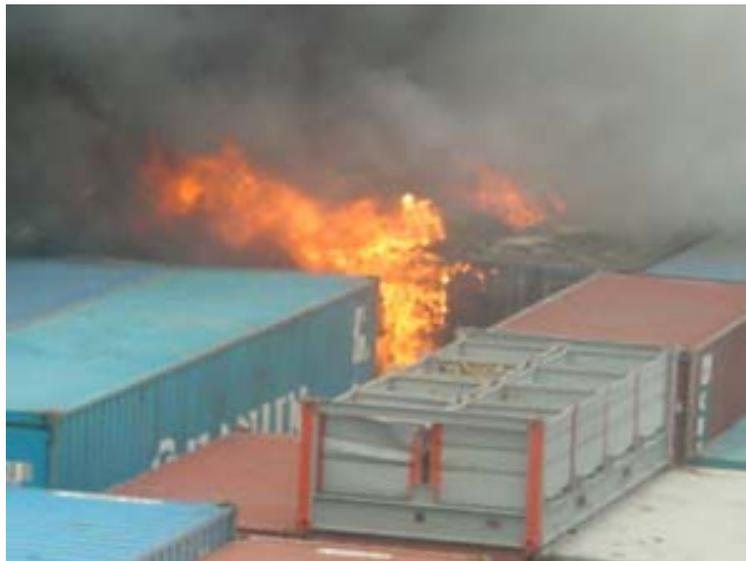
Photo 2. November 11th. Fires in containers above hold four on the port side.

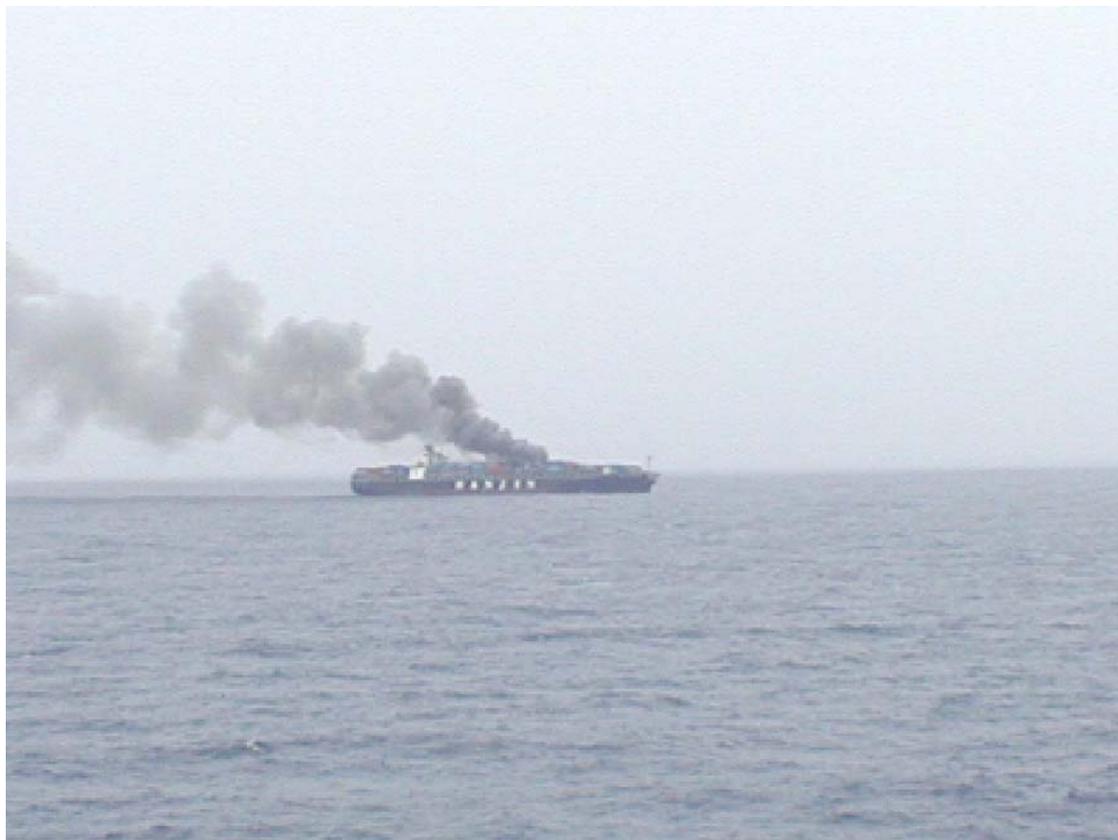
Photo 3. November 11th. M/V HANJIN PENNSYLVANIA (starboard) the morning of the first explosion above hold four. Fires continued to burn for 4-days and spread to containers above hold six forward of the accommodation.

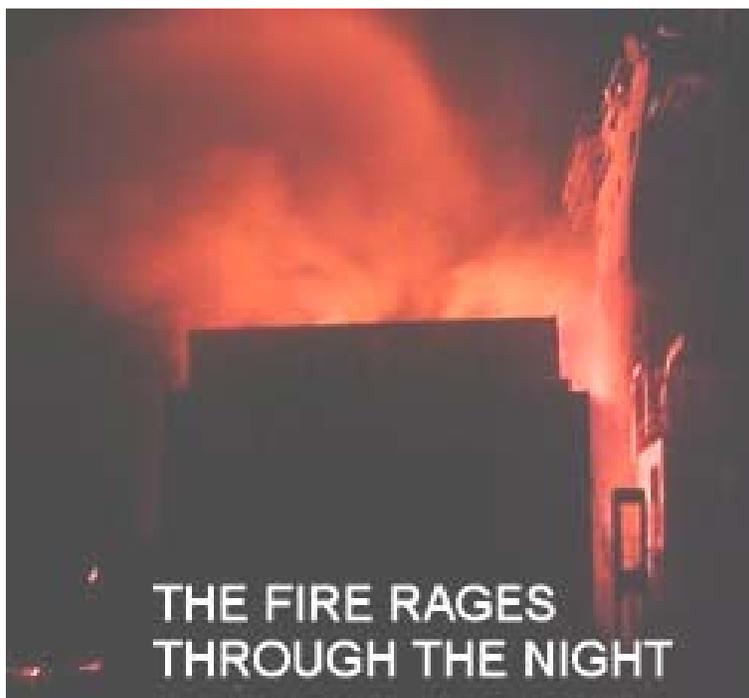
Photo 4. Containers above hold six and forward of the accommodation burning. Note the intensity of the fire and the location of the accommodation to the right.

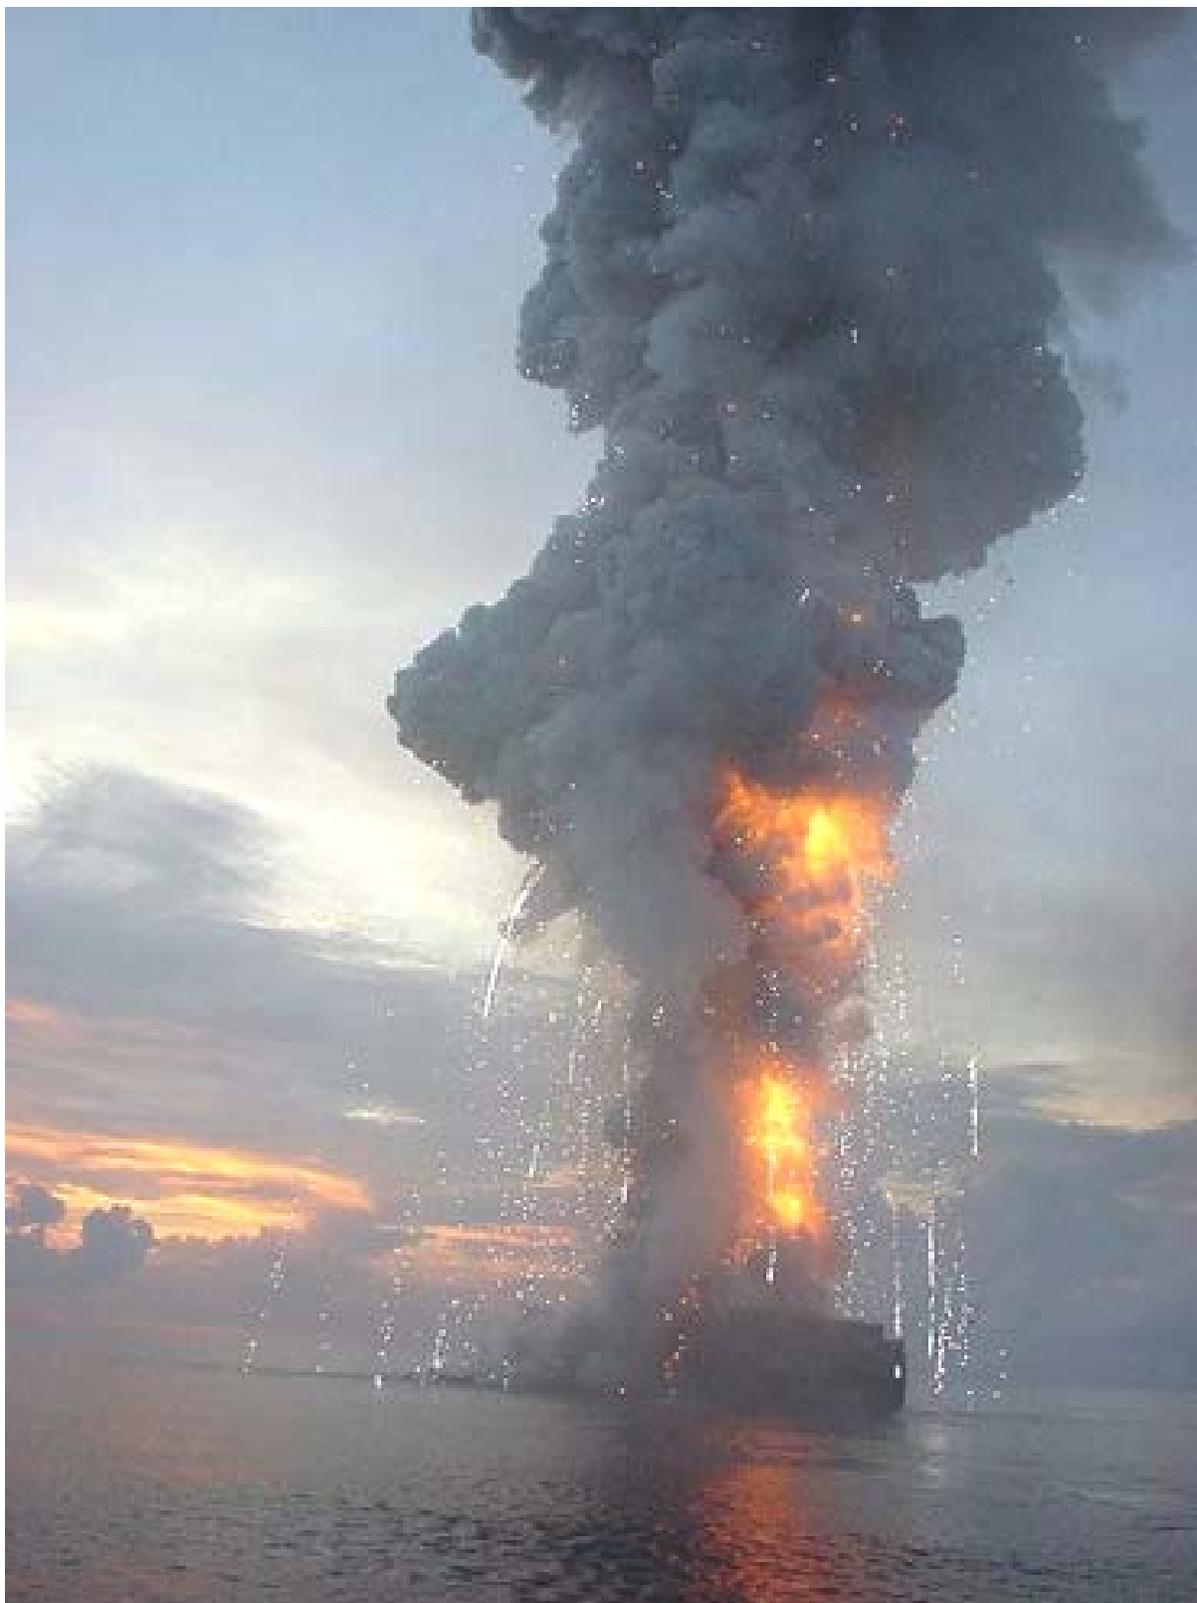
Photo 5. November 15th. The massive explosion in hold six aboard the M/V HANJIN PENNSYLVANIA. Note the large, rising orange fireball the tremendous plume of gray-black smoke and silver effects rising with the plume and then falling back to the sea.

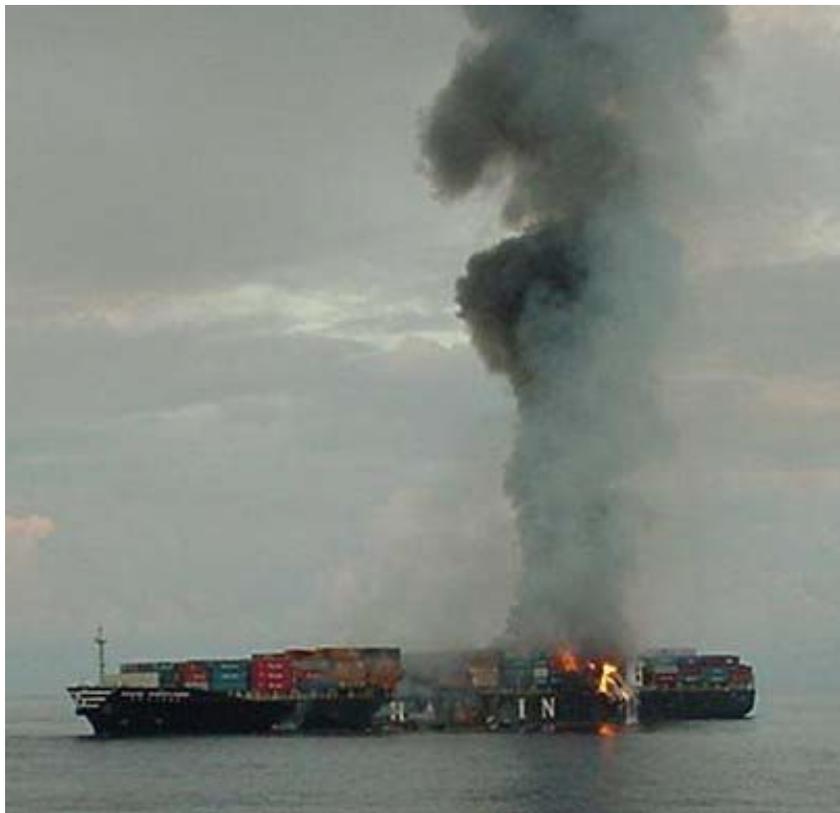
Photo 6. The M/V HANJIN PENNSYLVANIA (port) after the explosion of Nov 15th in hold six. Fires continue to burn above hold six and smolder above hold four. Note the missing containers above hold four and the plume of gray-black smoke from hold six.

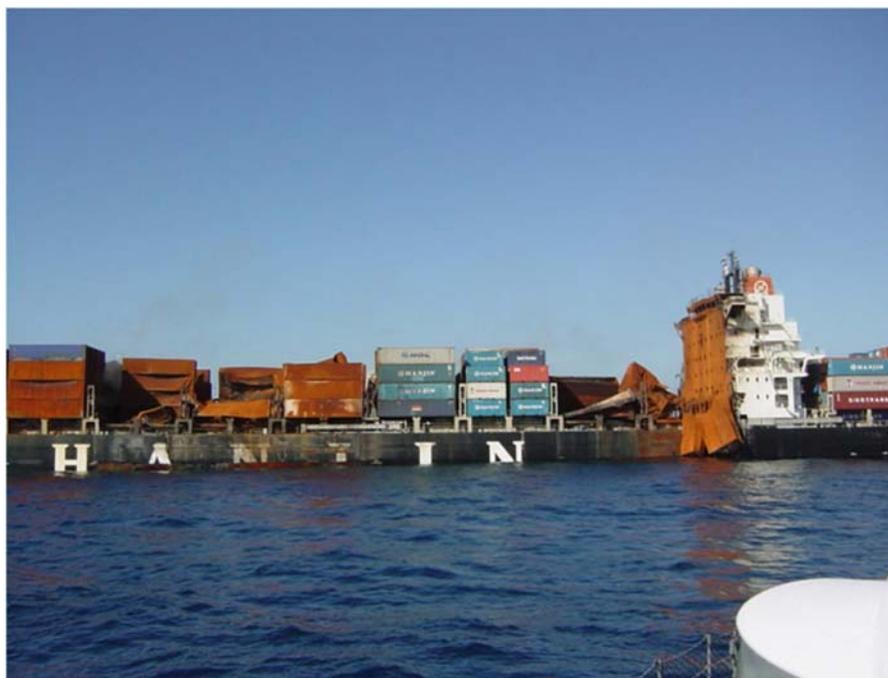
Photo 7. The M/V HANJIN PENNSYLVANIA (port) riding very low in the water as a result of fire fighting efforts. Note the burned containers above hold three and the missing and burned containers above hold four. Also note the raised and twisted deck hatch, the missing containers and heavy damage to the containers above hold six forward of the accommodation. Damaged containers above hold six are hanging over the port side

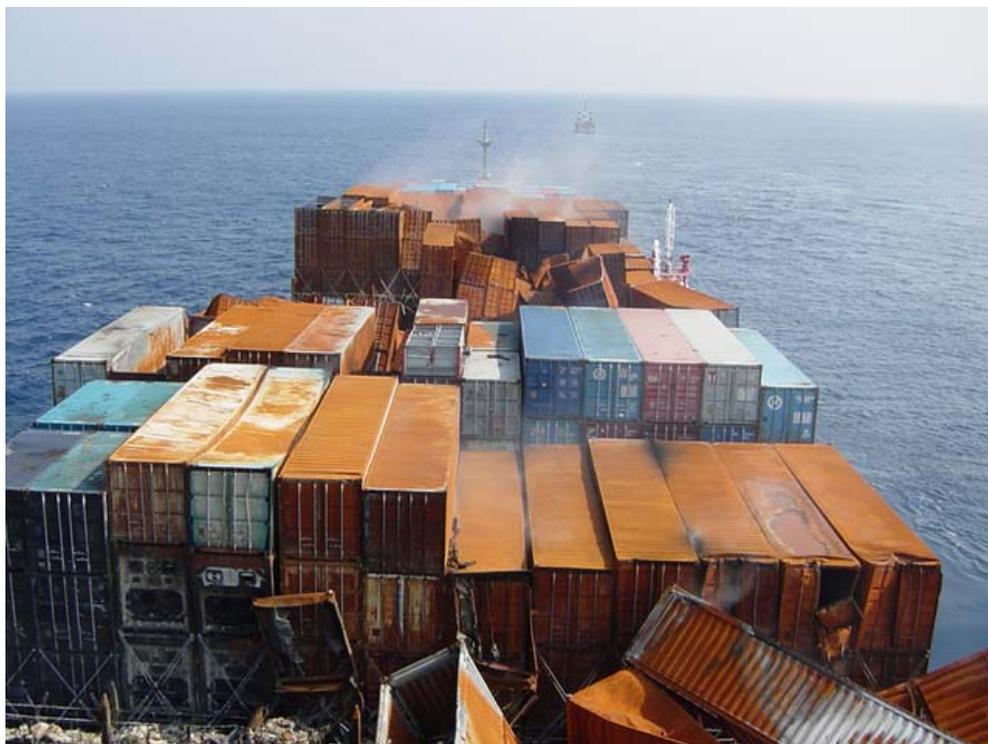
Photo 8. The view after Nov 15th from the accommodation of M/V HANJIN PENNSYLVANIA. Note the missing containers on the port side of hold 4 where the initial explosion occurred on Nov 11th.

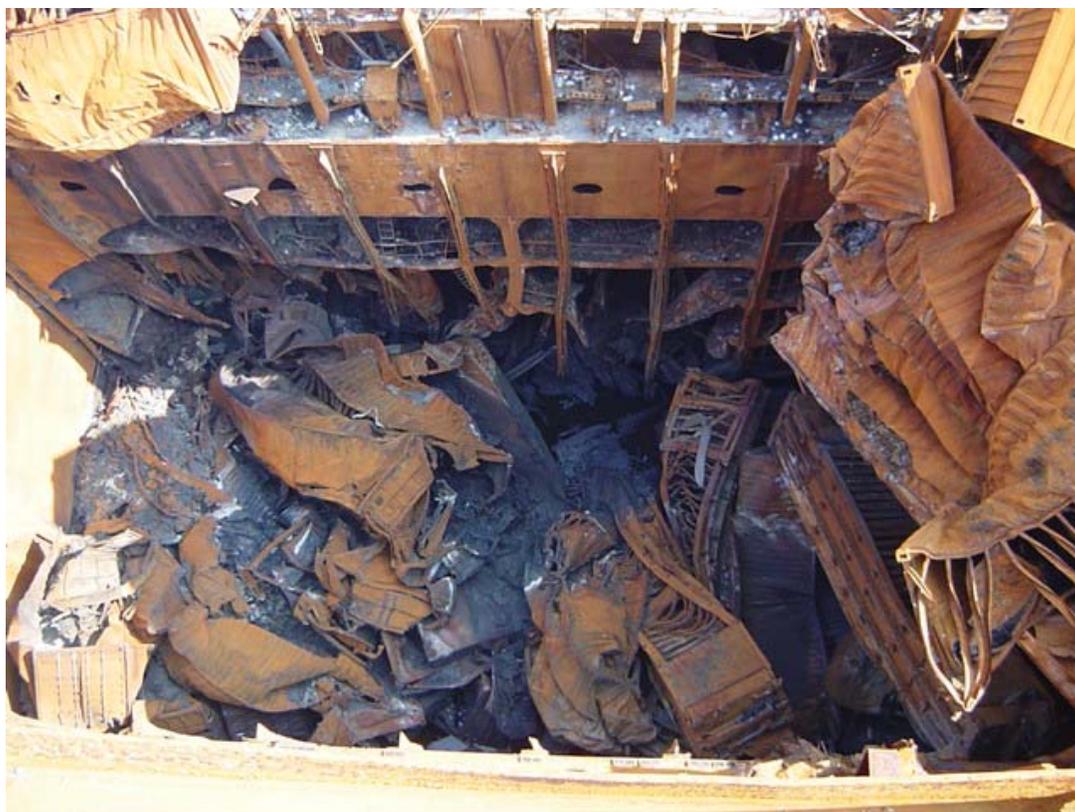
Photo 9. The aftermath of the Nov 15th explosion in hold six. Note the twisted wreckage here and compare to the containers above holds three, four and five.

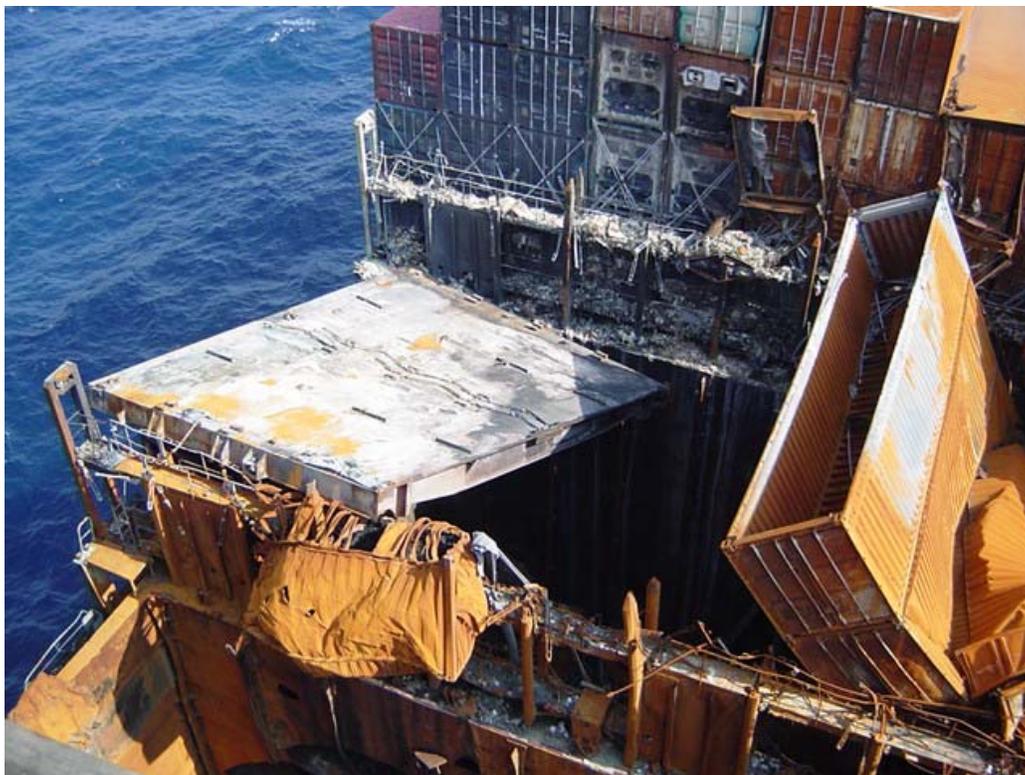
Photo 10. The aftermath of the Nov 15th explosion above hold six. Note the deck hatch (weight approximately 30 tons) that is normally held in place by a series of heavy pins.

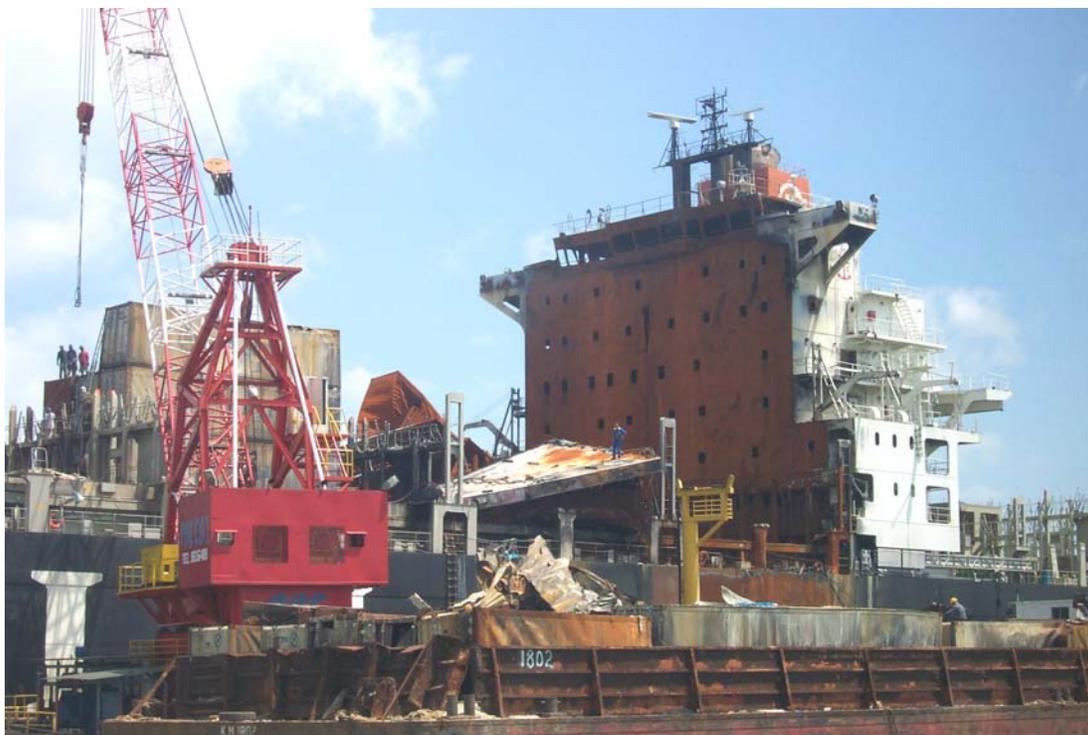
Photo 11. The M/V HANJIN PENNSYLVANIA (port) in Singapore during salvage and recovery operations. Note the twisted and upraised deck hatch now resting in the port side forward rack above hold six. The deck hatches from the port side and center racks in the aft rack of hold six are missing.

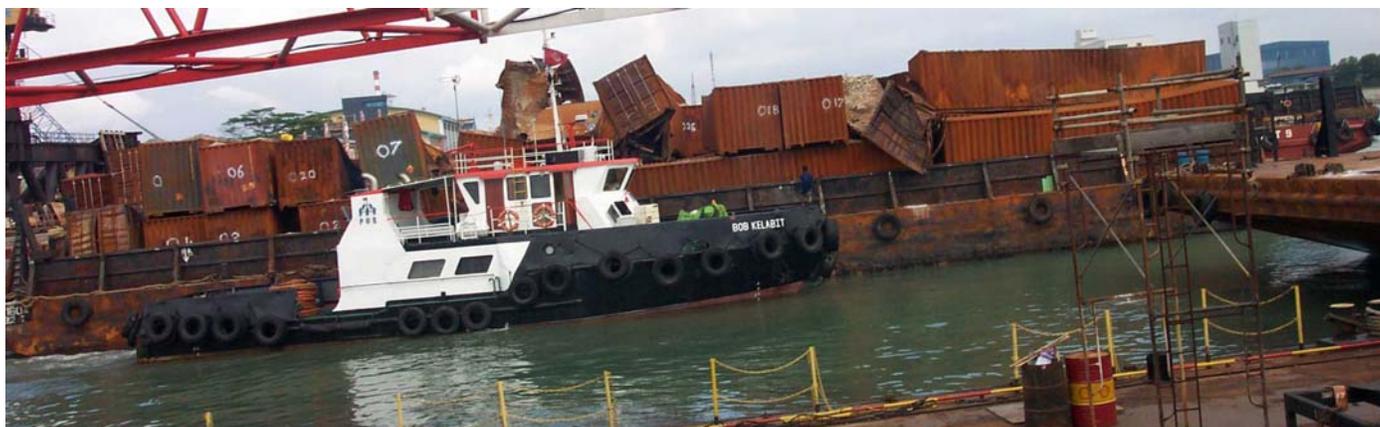
Photo 12. A barge in a Singapore salvage yard with burned out containers from M/V HANJIN PENNSYLVANIA. Note the orange 1.4G placards on the containers to the left (0#, 06 and 07) that curiously survived in spite of the fact the paint did not.

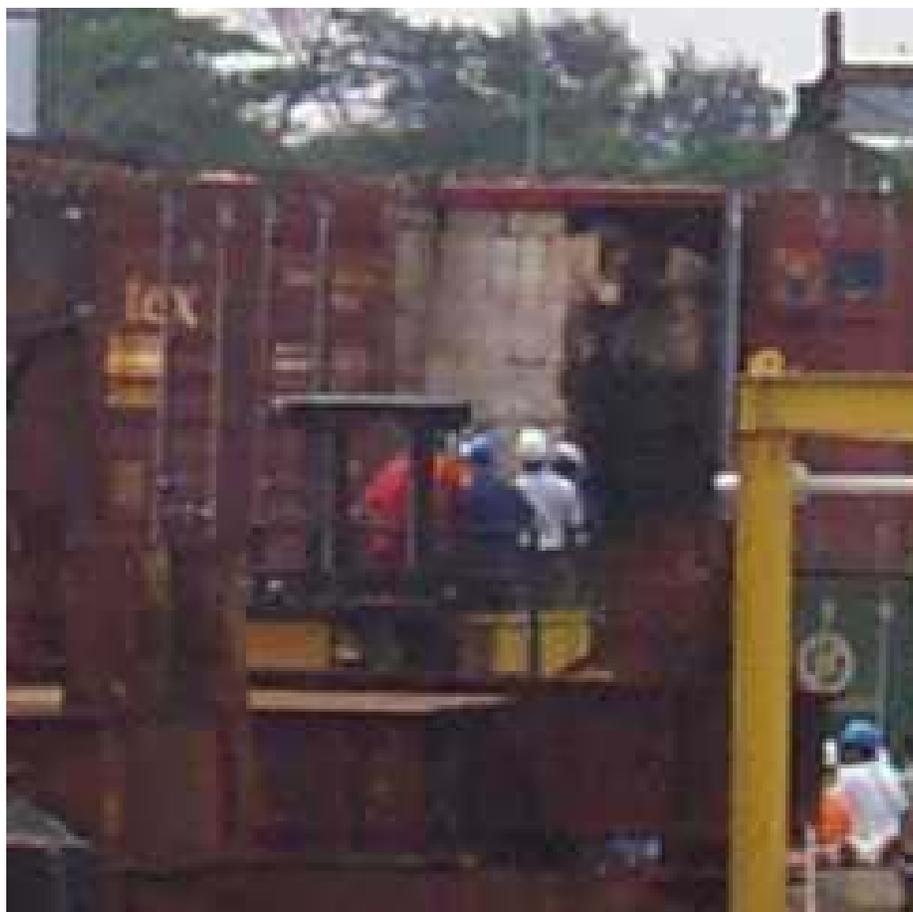
Photo 13. A container with fireworks from the M/V HANJIN PENNSYLVANIA is surveyed in Singapore. Note the cartons to the right and nearest to the door have heavy fire damage but the cartons to the left do not. A motorized forklift is being used to lift the General Average and some surveyors to view the top tier of over 50 containers of fireworks. About 20 other people viewed this from the ground. Cutting and grinding as well as other metal salvage operations continued in the vicinity of this busy salvage yard. These containers were handled from the ship to the salvage yard despite the fact many of these containers were water logged from the fire fighting efforts and had been exposed in the equatorial sun for over a month.

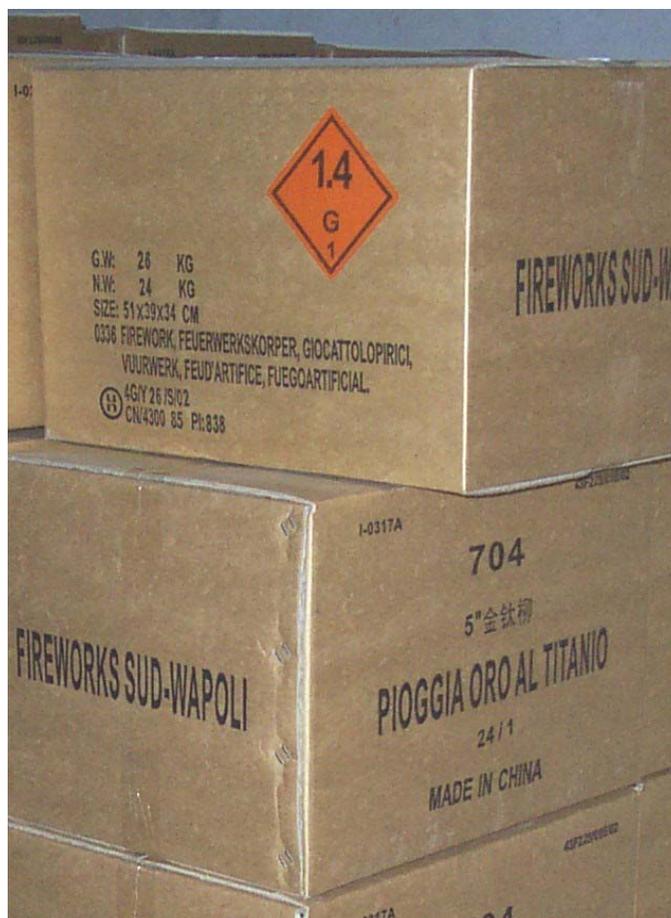
Photo 14. A warehouse full of 5” and 6” aerial fireworks shells in a Chinese warehouse await shipment to a European customer. Note the 1.4G classification and the various European language descriptions on the top carton of 5” aerial shells. These same aerial fireworks would be classified as 1.3G if shipped to the United States and other markets.

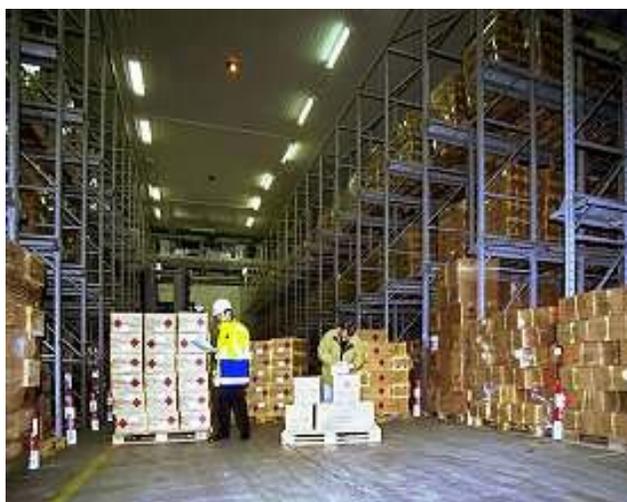
Photo 15. A distribution warehouse utilizing rack storage for imported 1.4G fireworks in Hamburg, Germany. No sprinkler system is apparent and the stacks of cartons on these pallets are not stabilized. Electrical systems do not appear to be explosion proof and motorized equipment is clearly used to move the pallets of fireworks. Distances from this building to other buildings and public areas is not known.
