M/V Hanjin Pennsylvania: Explosions at Sea

This report was prepared on behalf of the National Fireworks Association (NFA).

Final Report - Pictures

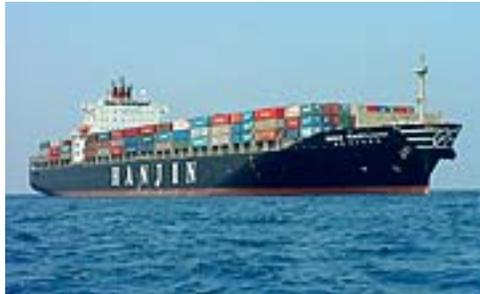
Photo 1. The newly built M/V HANJIN PENNSYLVANIA (starboard) fully loaded with containers. Holds one-six are from the bow to the accommodation, holds seven and eight are from the accommodation to the stern. Note how high in the water the ship is in this picture.
